Project Report

Laindatang Water Connections

Phase III - 2024

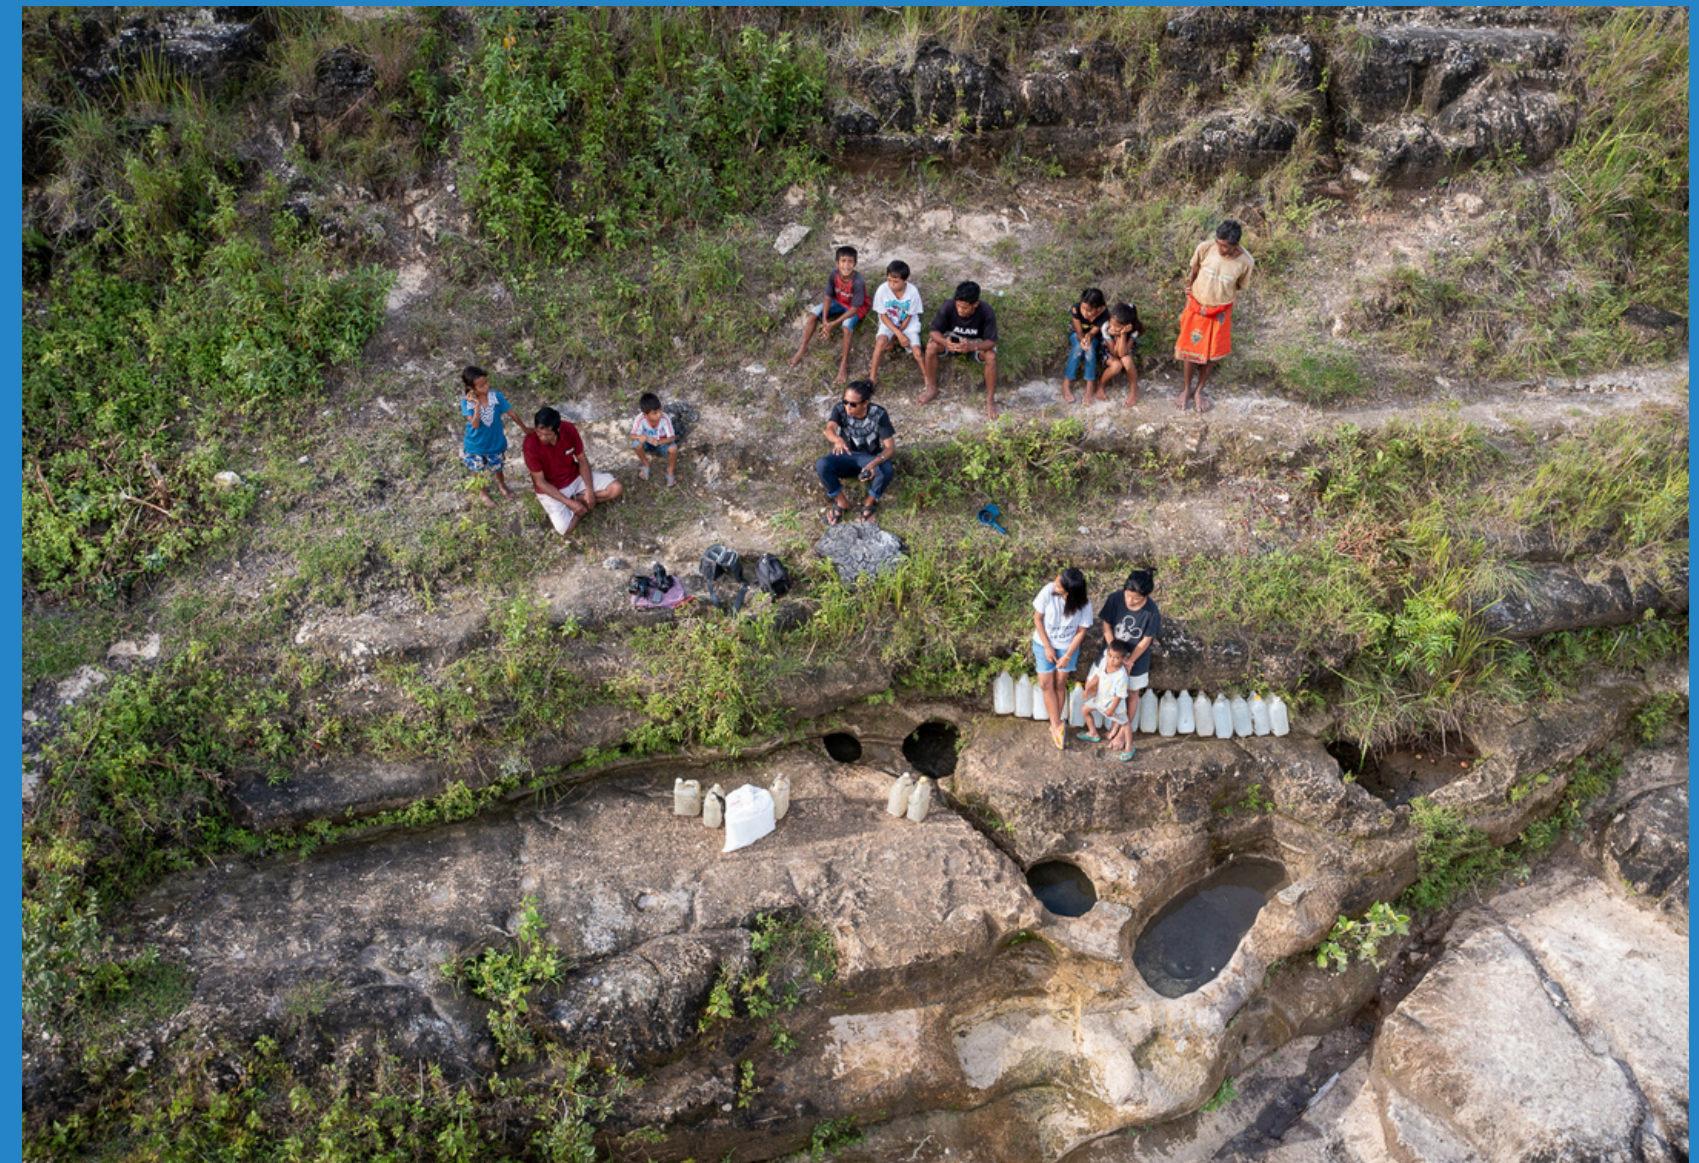
Residents collect water from a spring located on a ridge, requiring a 3 to 6-kilometer walk on foot from their settlement.

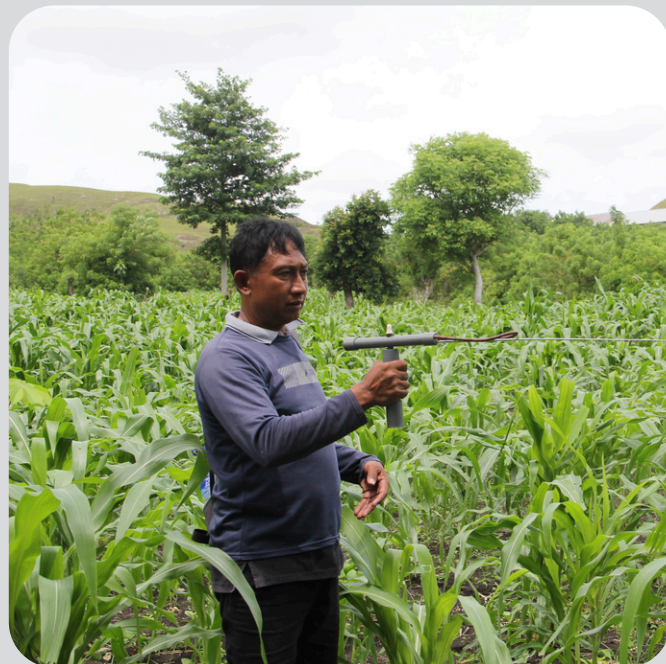
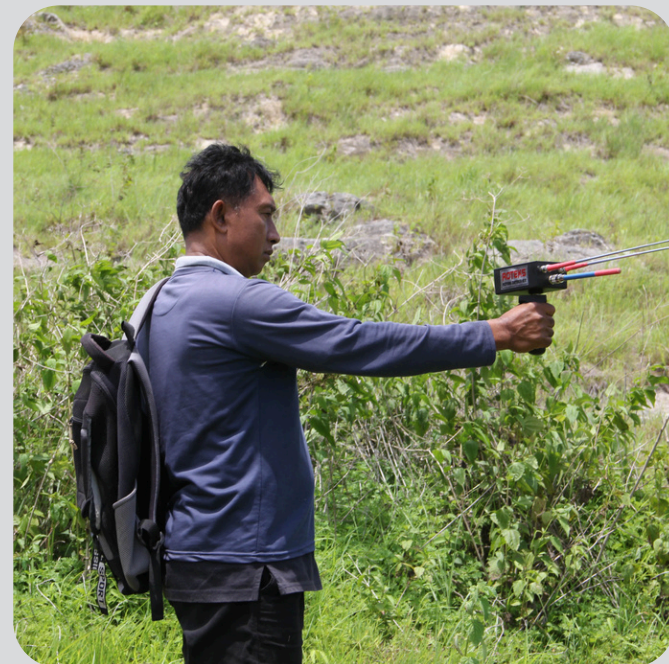
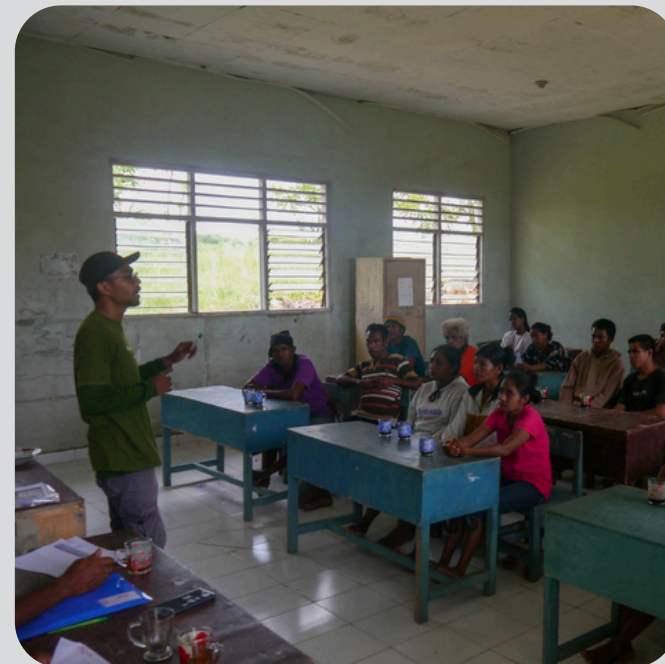
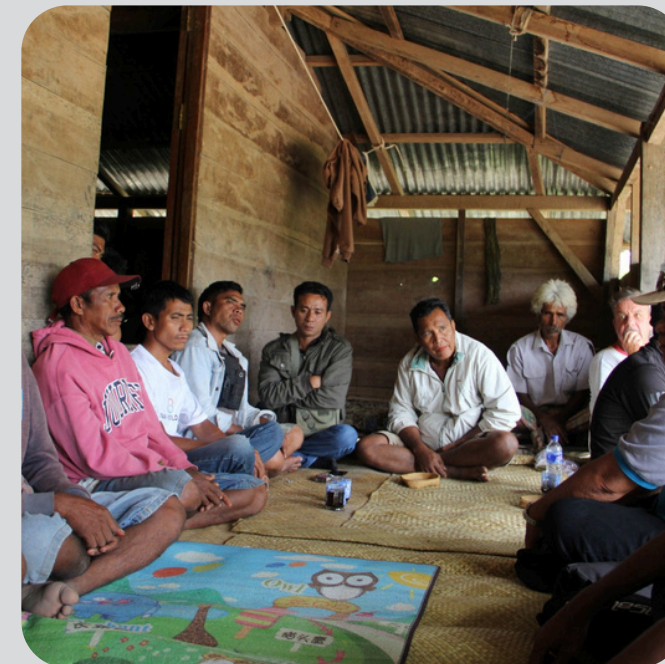
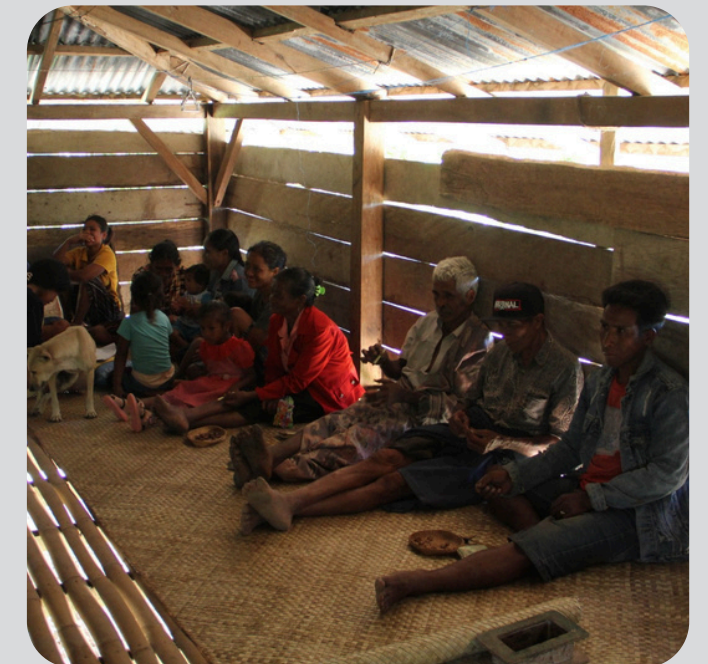
Drilling Point Survey

The initial survey identified three potential drilling points for the well process. These points are estimated to reach depths of between 30 and 85 meters. However, the water discharge at these sites is low, meaning the flow is not rapid, and the continuity is limited (the pump is expected to stop after 1-3 hours of use).

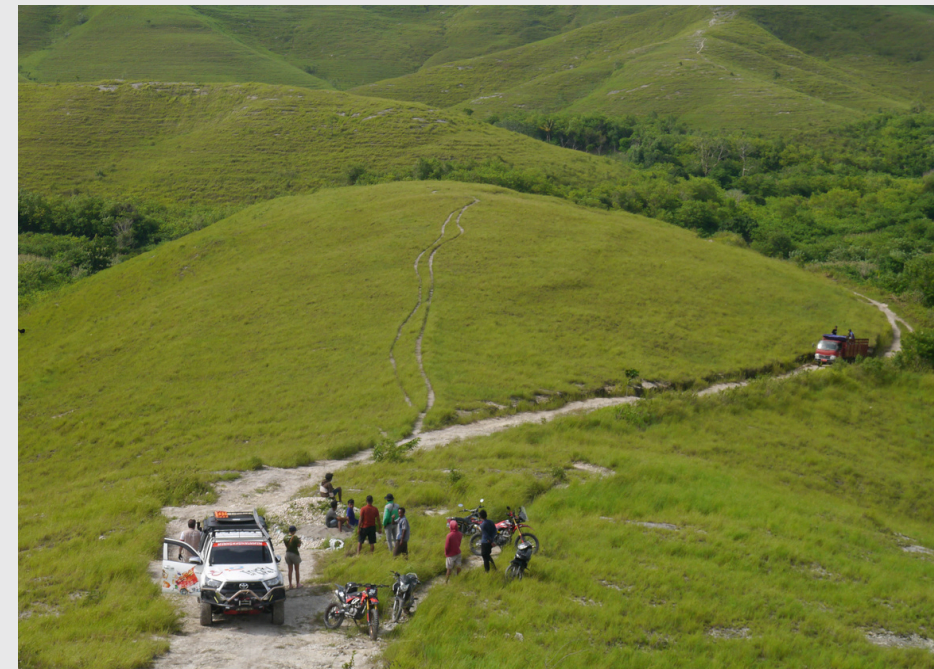
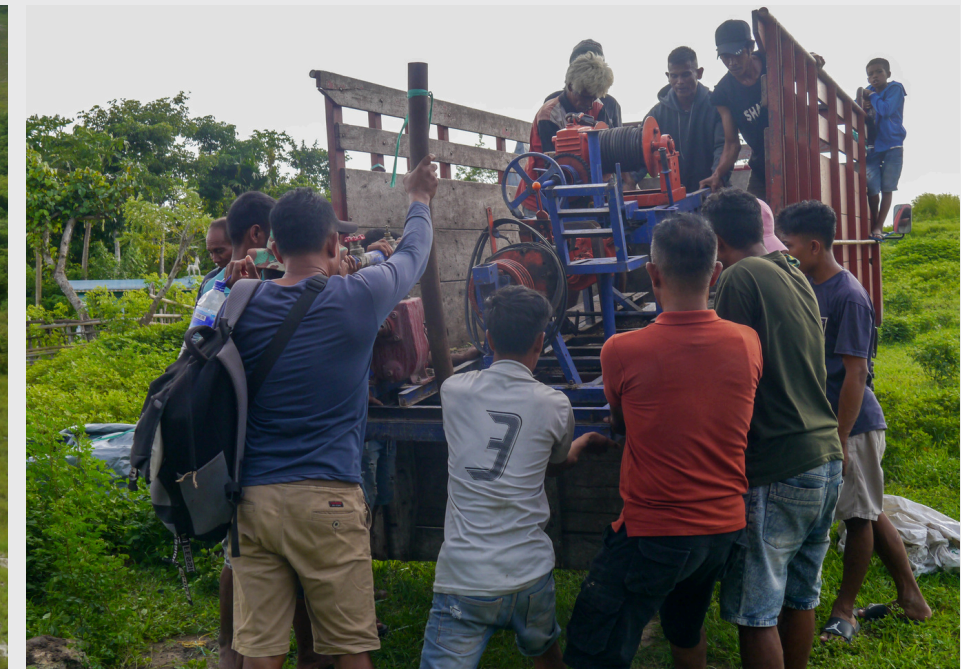
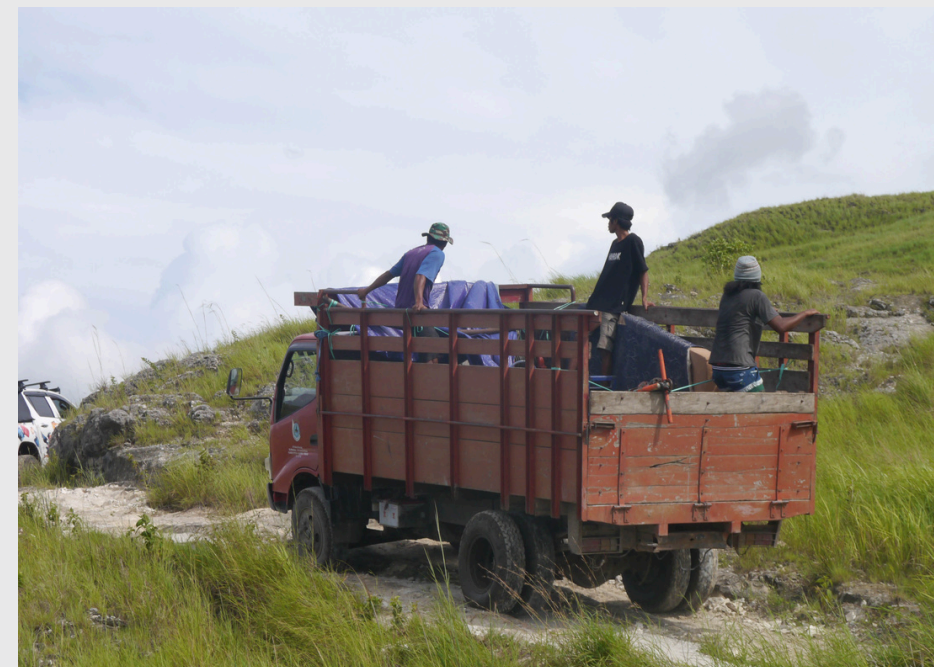
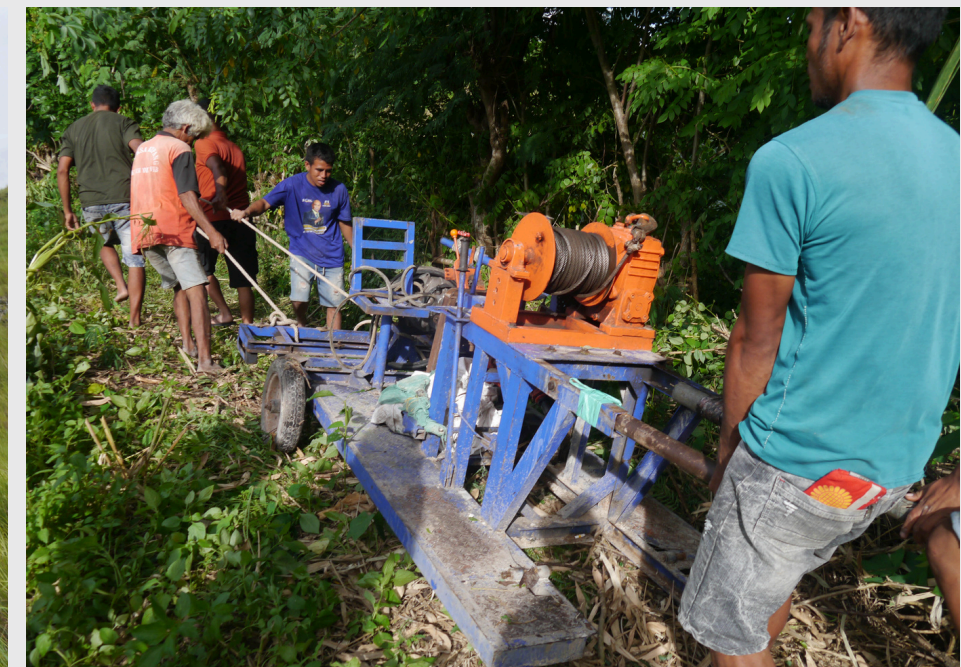
Mobilization of Materials and Drilling Machines

Due to the difficult road access to the drilling site, trucks carrying machines and materials must stop some distance away. Transporting the materials and equipment to the site requires skilled drivers, and we sought assistance from the government to provide the necessary personnel.

The mobilization process is led by the Truck of Life, driven by Alex from the Fair Future Foundation (FFF), with residents supporting the transport by hand in a spirit of cooperation. This activity takes place from morning until night. Additionally, heavy and prolonged rainfall further complicates the process.

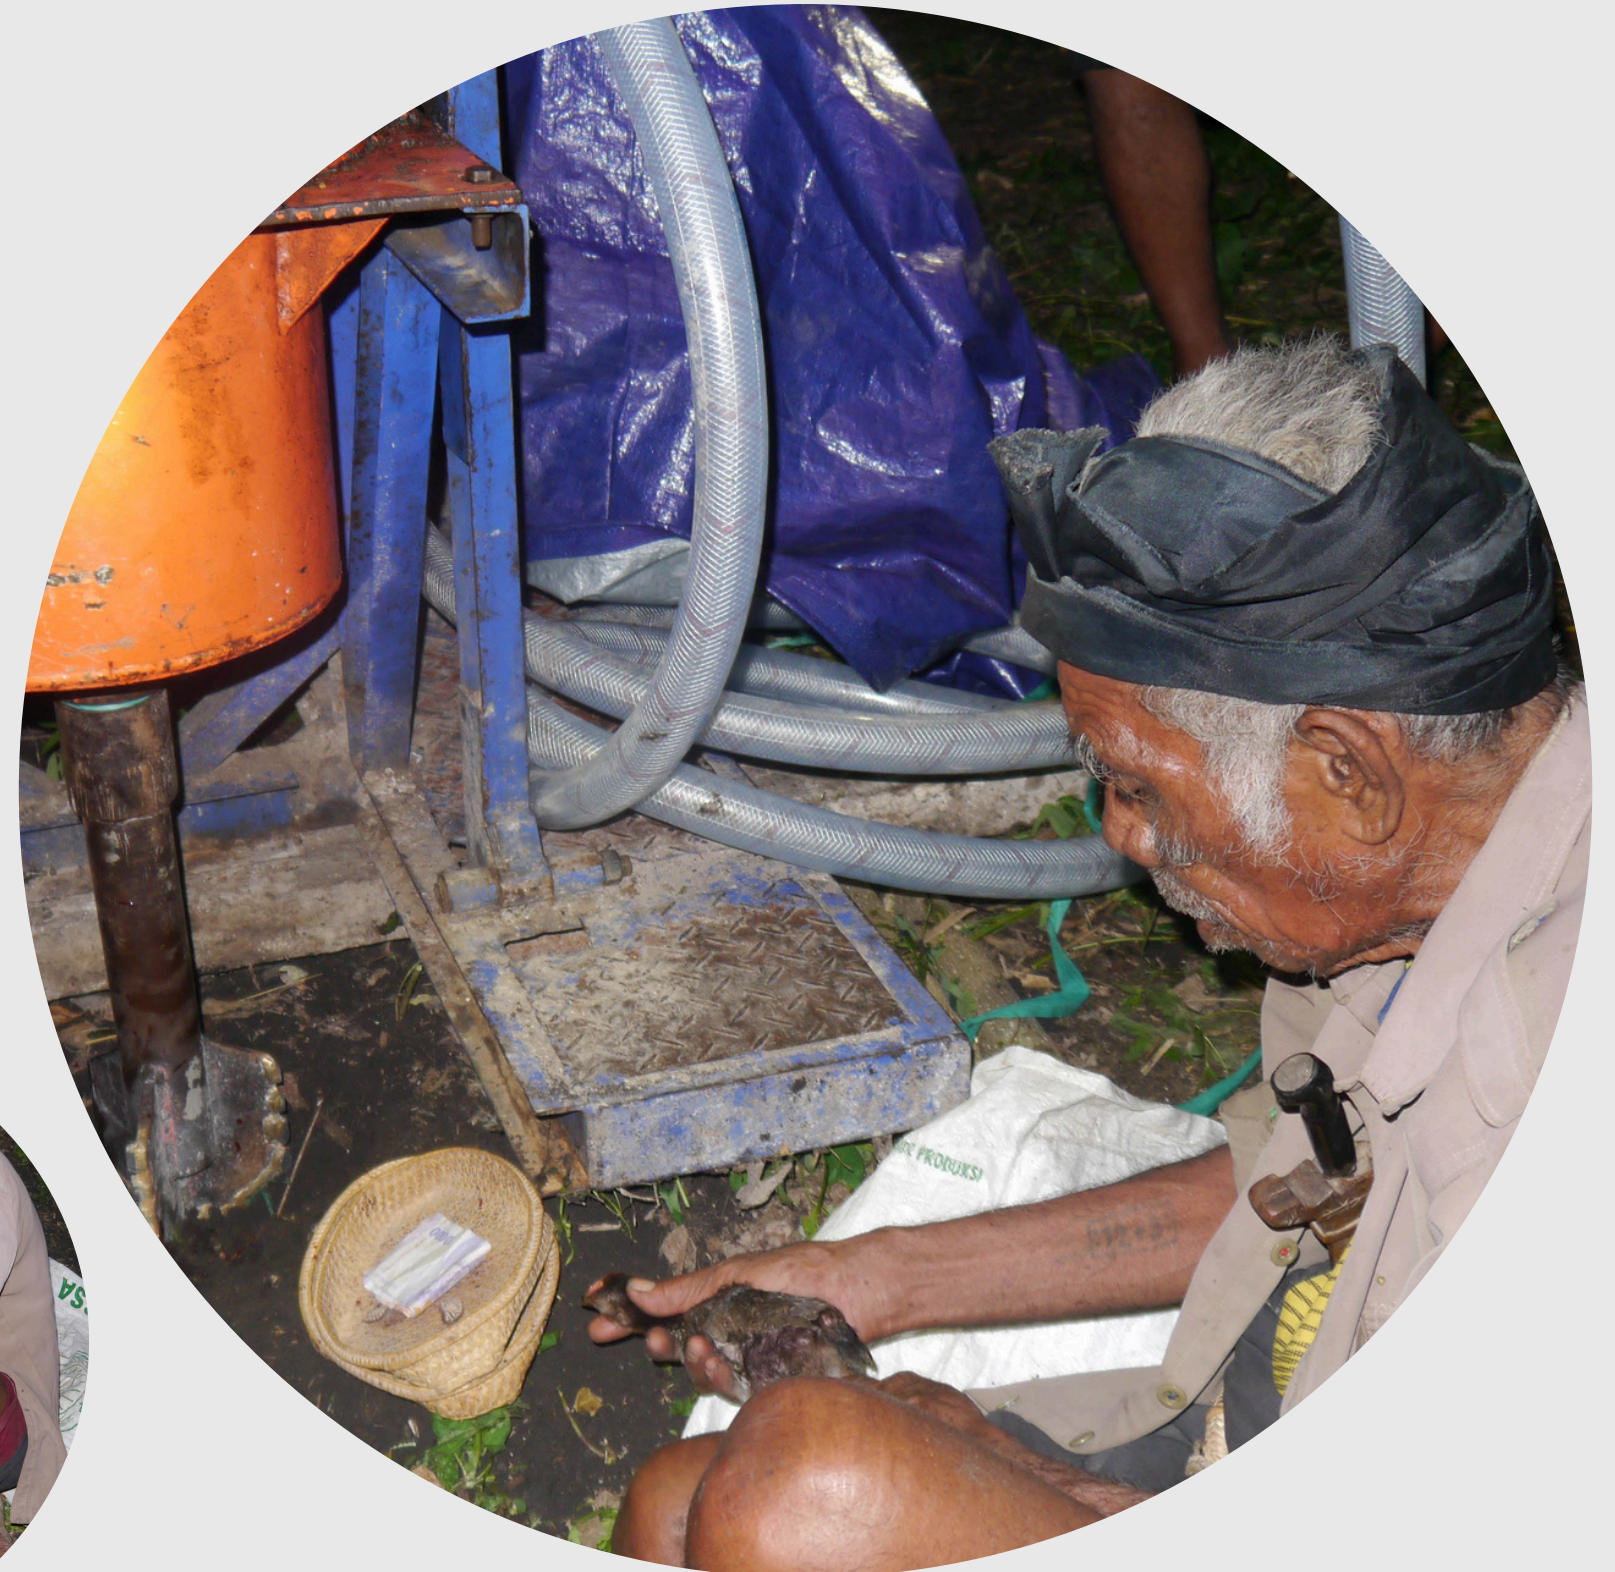
Drilling Point 1

depth of the well
84 meter

Soil **cavities**
caused the water
to **vanish**

The first drilling attempt took place from February 23 to March 22, 2024, reaching a depth of 84 meters. However, the targeted underground water flow experienced a water loss, leading to the decision to relocate to a new drilling point.

Constraints:

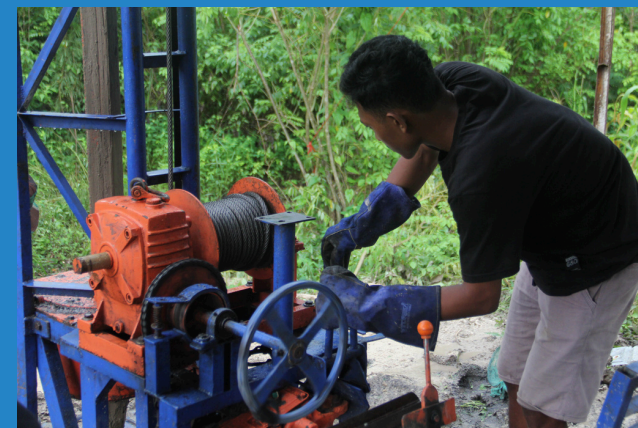
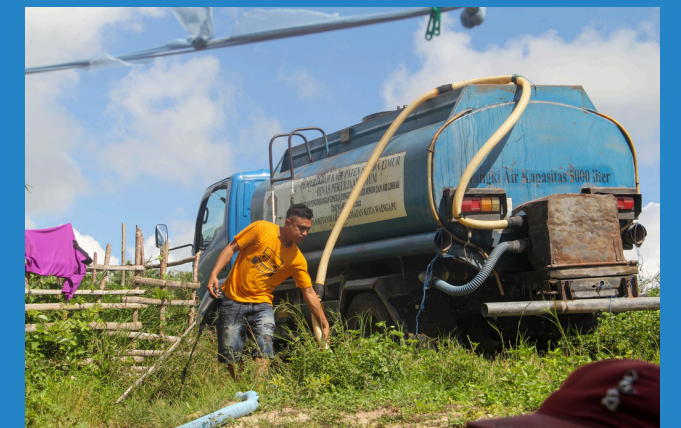
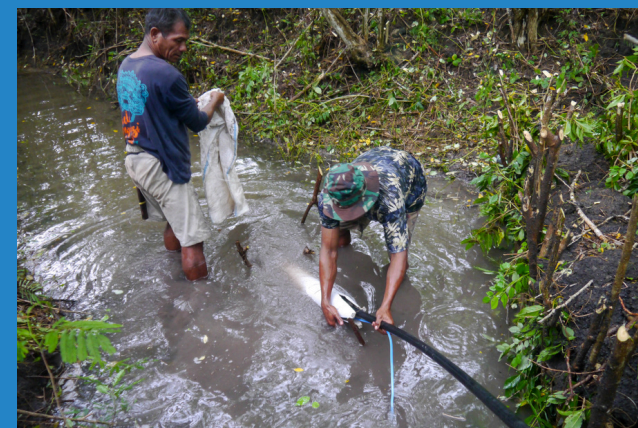
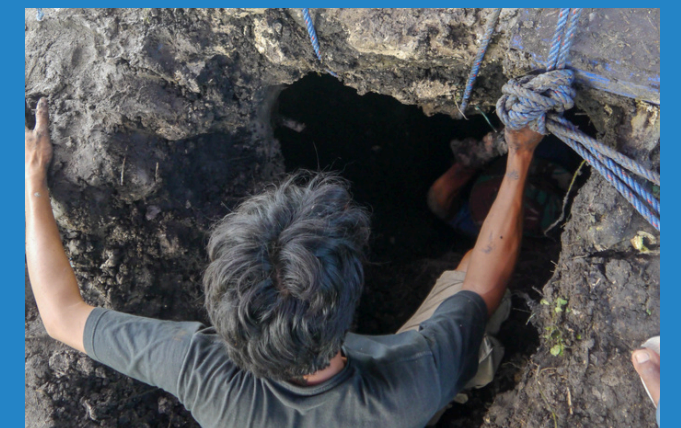
Drilling Point 2

Casing blockage

Drilling began on March 29, 2024, and reached a depth of 32 meters over approximately two weeks. The water in the well rose to 17 meters from the bottom, but during the casing pipe installation, water discharge rapidly decreased until pumping was no longer possible, resulting in water loss.

Constraints:

- Casing blockage obstructed the water flow during pipe installation,
- The well wall collapsed, closing the deep excavation hole,
- After a week of monitoring, water discharge did not improve, leading to the decision to move to a third drilling point.

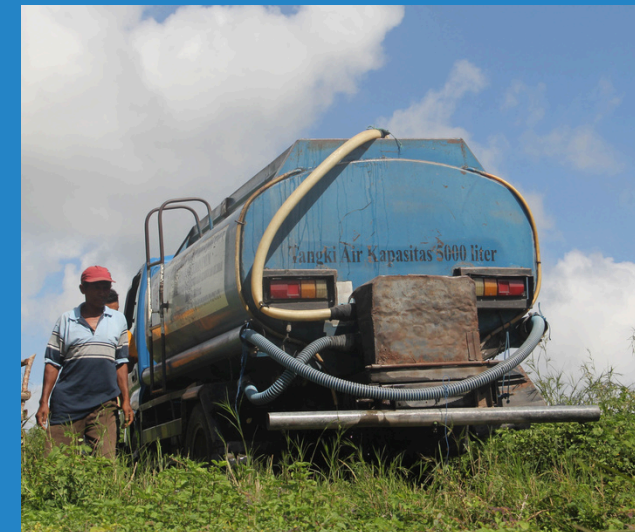
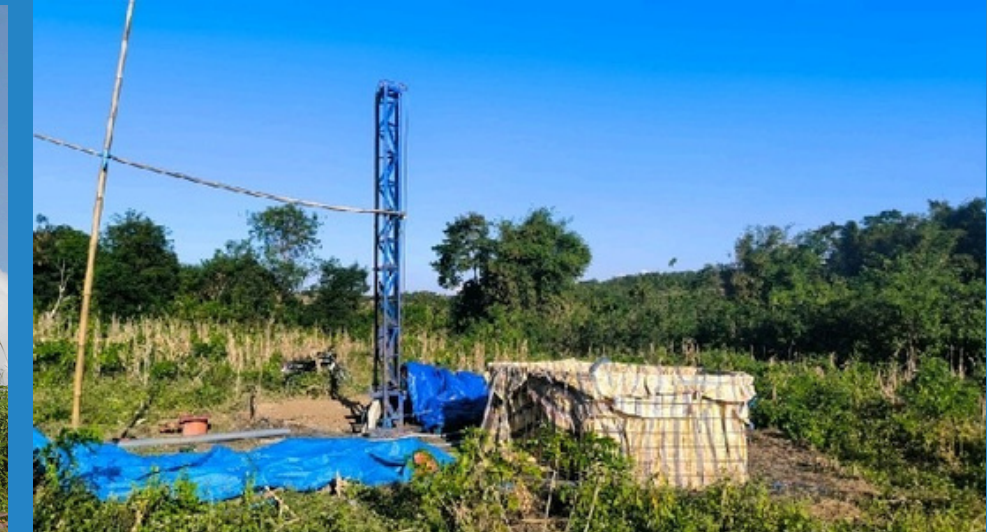
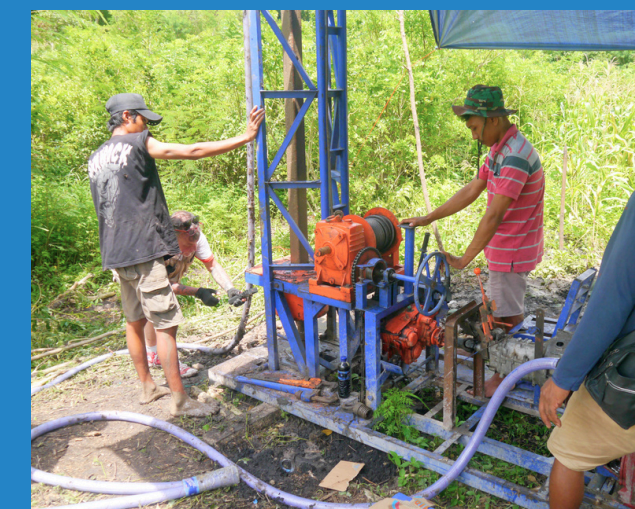
Drilling Point 3

Failed to reach aquifer spring point

In 1 week and 4 days, a depth of 52 meters was reached, using up to 6 trucks during the process.

Constraints:

- Water discharge was too low, producing only 120 litres in 7 minutes. Subsequent tests showed a decrease in discharge and instability,
- The casing pipe installation was partially unsuccessful, with only 4 out of 10 pipes removable,
- The aquifer did not recharge sufficiently, and no aquifer spring was found—only rainwater infiltration flows were present.

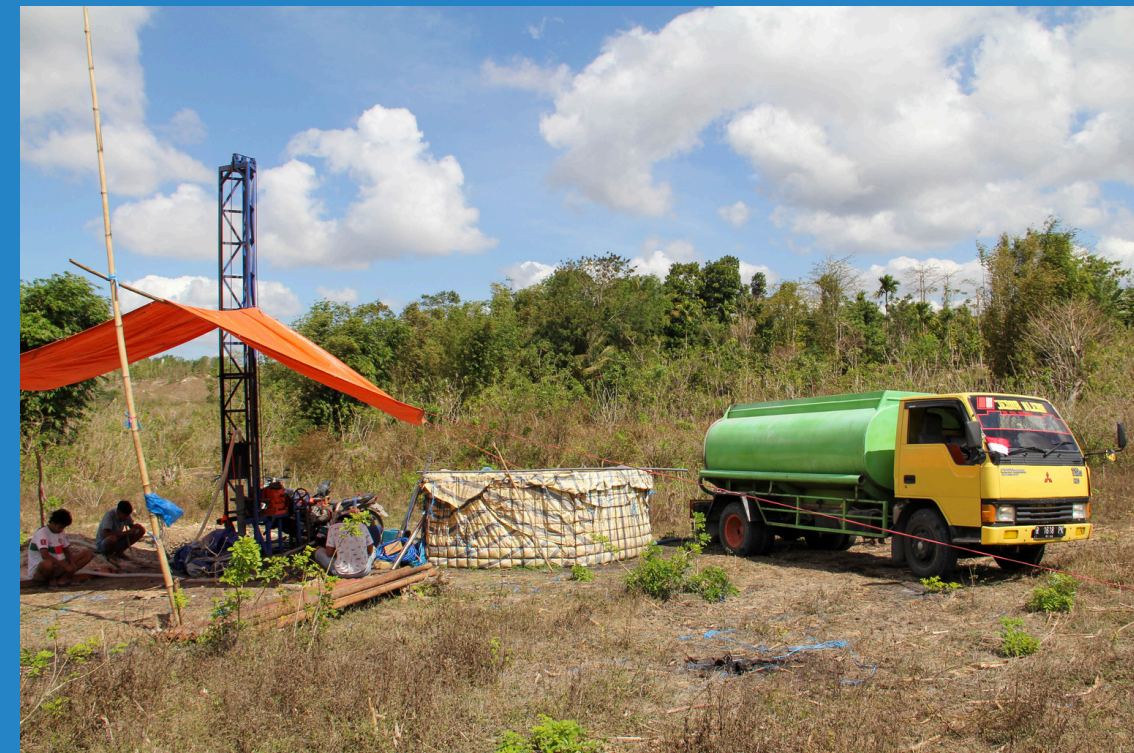
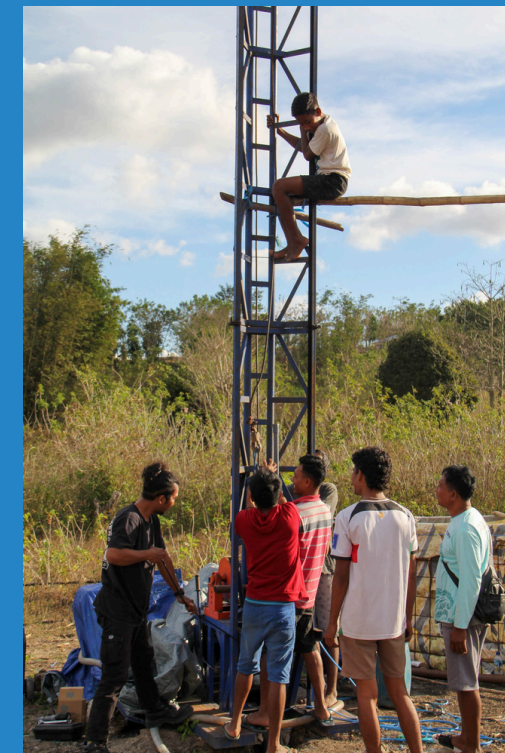
The drilling process at this point, conducted from May 23 to June 30, is critical for determining the success of future wells.
